Technical Report
FCRC-TR 96-07

Flashover Fires An Experimental Program

FCRC Project 4
Fire Safety System Design Solutions
Part A – Core Model & Residential Buildings

Fire Code Reform Research Program
October 1996

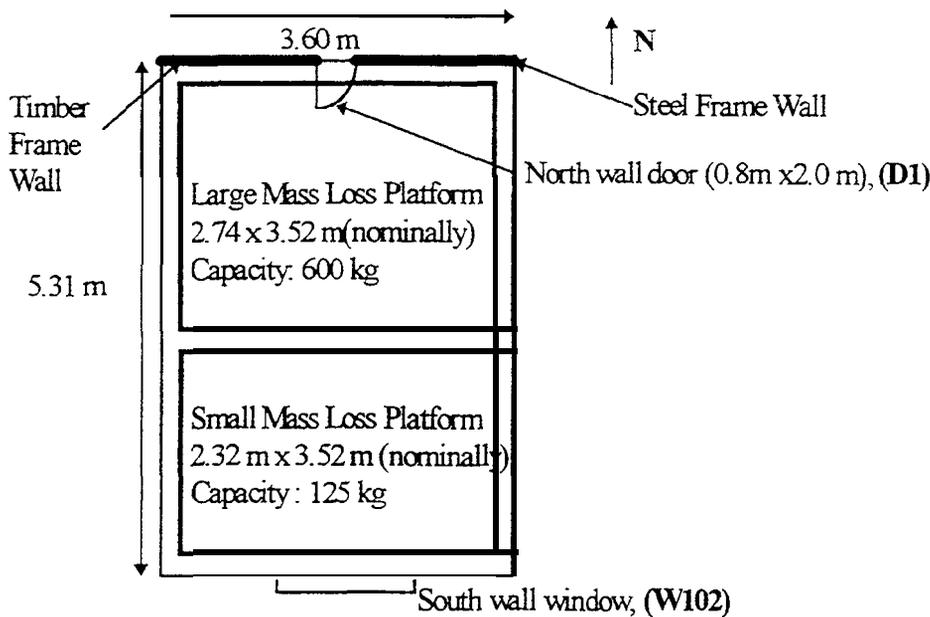
Figure 8: Plan View of the Burn Room

The flashover fires experiments were conducted on Level 1 in a large burn room (5.4 m x 3.6 m x 2.4 m), denoted as Room 102 in Figure 3. A standard size door, D 1, (820 mm x 2040 mm), is located in the center north face of the room. A one hour fire rated door is fitted in the frame, with a 15 mm gap at the base of the door for all closed door experiments. Opposite this door is a 2400 mm x 1500 mm window, W 102, in a standard three pane configuration (2 small sliding panels, 3 mm thick and one fixed glass sheet, 4 mm thick) as shown in Figure 9. When this window was closed no natural draught through the room was detected. The burn room walls were lined with 2 layers of 16 mm fire rated plaster except on the north wall which is described later and the ceiling was lined with 3 layers of 16 mm fire rated plaster. It was decided to use this extra lining in the burn room to ensure the fire would not spread to adjacent rooms and to the levels above as this experimental series was concerned with smoke and fire spread via openings rather than through barrier failures. For the test where the sprinkler was charged with water (FO8) there was only 1 layer of plaster on the walls and 2 layers of plaster on the ceiling.

The north wall (which contains the door to the corridor) was constructed in two parts- one side of the wall was replaced with a timber frame section and the other half was made up of a standard steel frame, as shown in Figure 8. A single layer of 16 mm fire rated plaster lined both sides of the wall to form a standard 1 hour fire rated wall. The door to the corridor was not attached to the frame during tests which had the door in the open position.

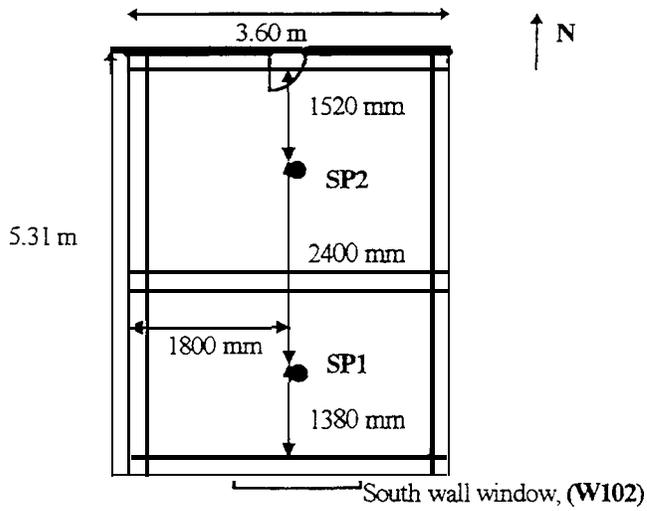
The actual system was designed according to Section 9 “Light Hazard Class Systems” of the above Standard. There are two charged sprinklers in the burn room as shown in Figure 11. These sprinklers are fitted with 10 mm nominal bore (3/8” BSP), 68°C bulb type heads. The minimum pressure at each head is specified to be 70 kPa, which corresponds to a discharge of 48 l/min. This gives a density of discharge of 5.0 mm/min

in the burn room. These heads were positioned with the water diffuser at 85 mm from the ceiling.

Figure 11: Sprinkler Locations in the Burn Room

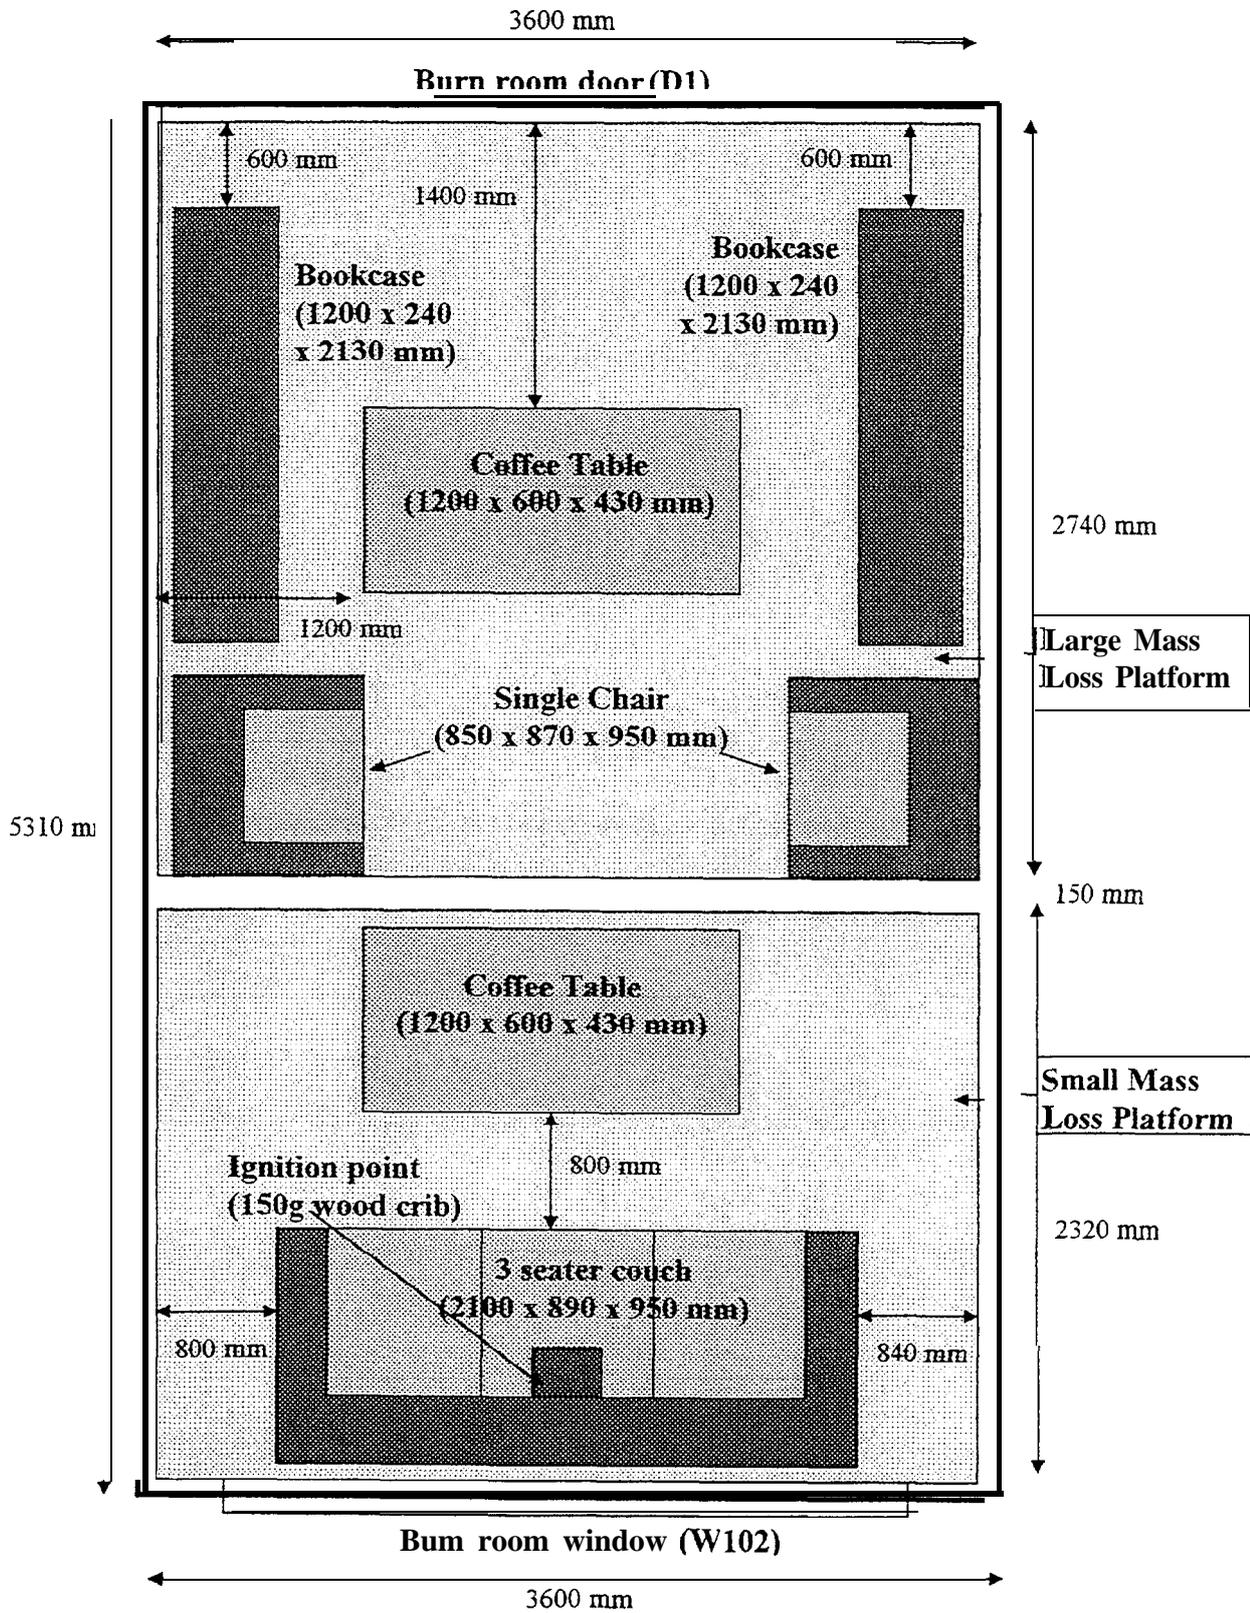
There was also a strip of carpet and underlay 150 mm wide along the center of the room between the two mass platforms weighting 1.56 kg. Although the mass loss of this piece of carpet and underlay was not measured it only represented 0.2% of the overall fuel load in the room and it was considered far more important to ensure spread across the two platforms.

Figure 12: Fuel Load Layout in the Bum Room

The source of the ignition for all the fire tests was a standard wooden crib weighing 150g, using 200 mm x 3.5 mm sticks. This was placed on the center seat of the 3 seater couch on the small platform as shown in Figures 12 & 16.

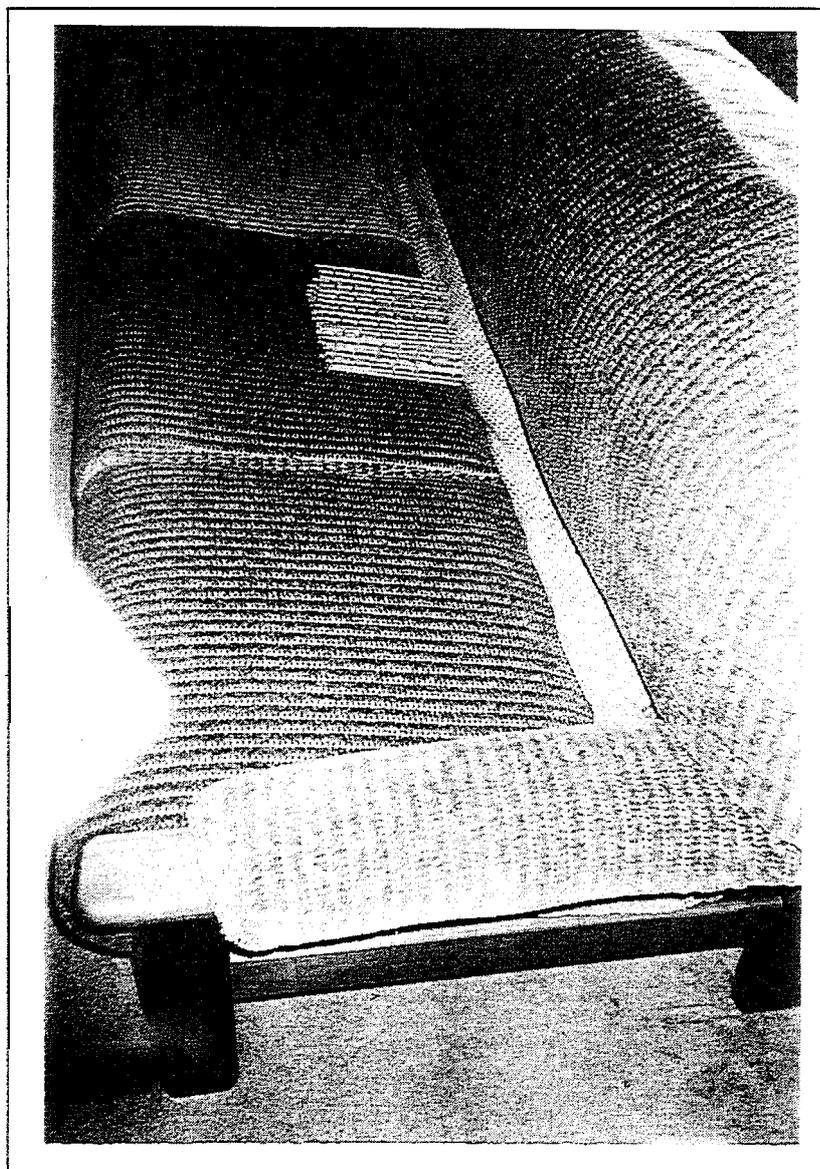
Figure 16: Ignition Point on the three seater couch

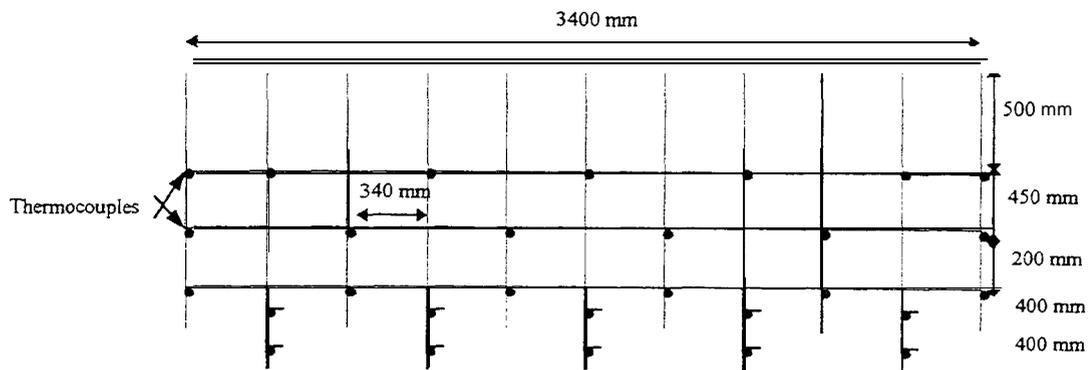
There are two thermocouple racks located within the burn room, one in the north-south direction and the other in the east-west direction. There are 35 thermocouples distributed on each on these racks, which were mounted 250 mm from the ceiling. The configuration is shown in Figures 18 and 19 and the location of the racks in the burn room is shown in Figure 21.

Figure 18: East-West thermocouple rack in burn room (Total 35 thermocouples)

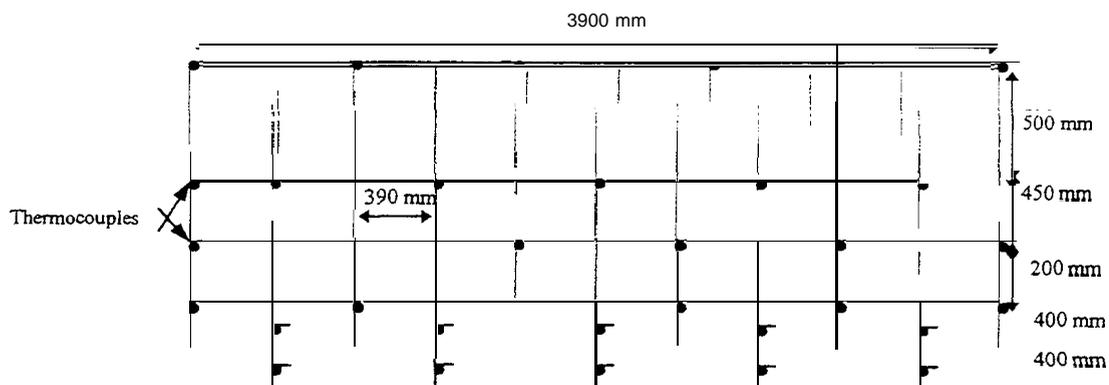
Figure 19: North-South thermocouple rack in burn room

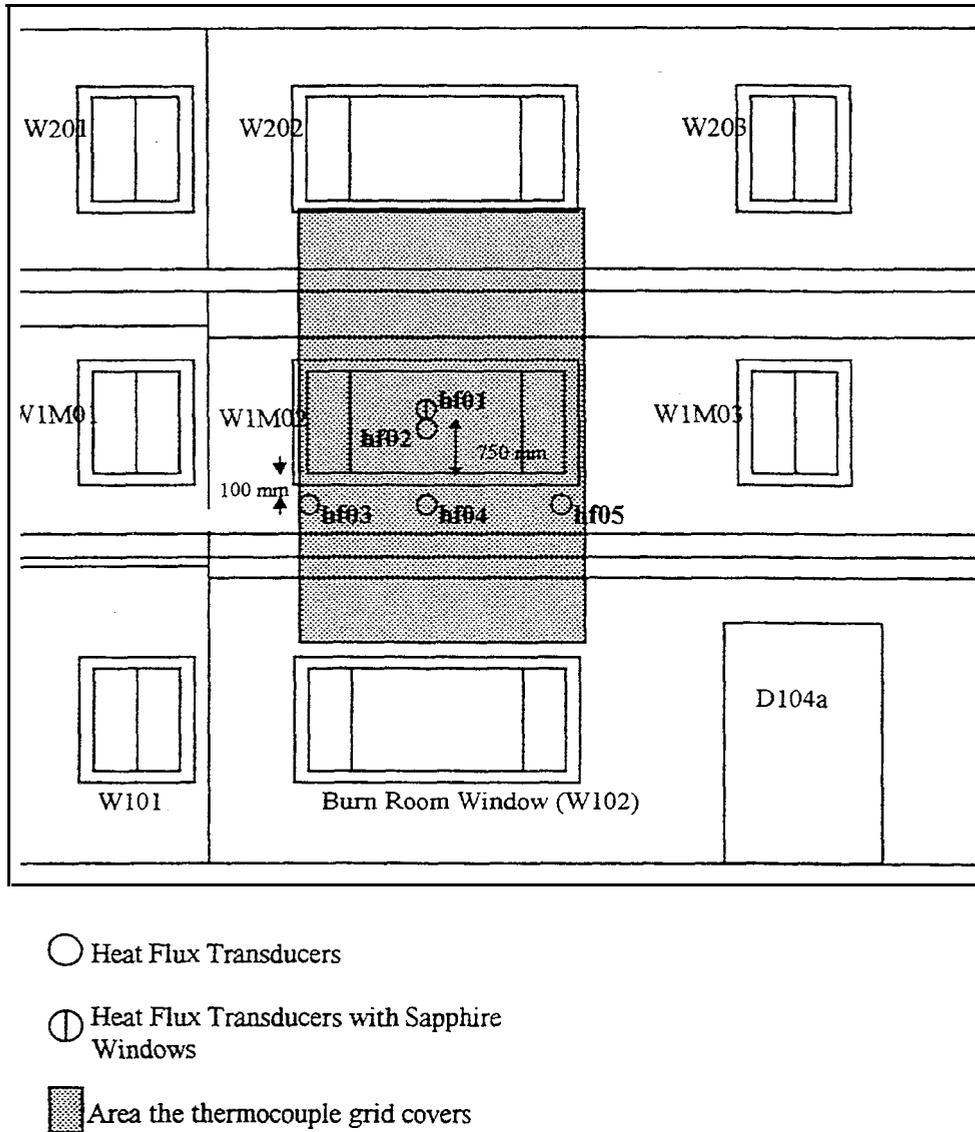
The instrumentation on the facade of the building directly above the window consists of 5 heat flux transducers and a 3-D thermocouple rack. This 3-D grid is mounted to the external facade of the building just above the burn room window. There are 140 thermocouples points on this grid as shown in Figure 27. The location and dimensions of the external instrumentation are shown in Figure 26.

Figure 26: Instrumentation on the external facade (south side) of building

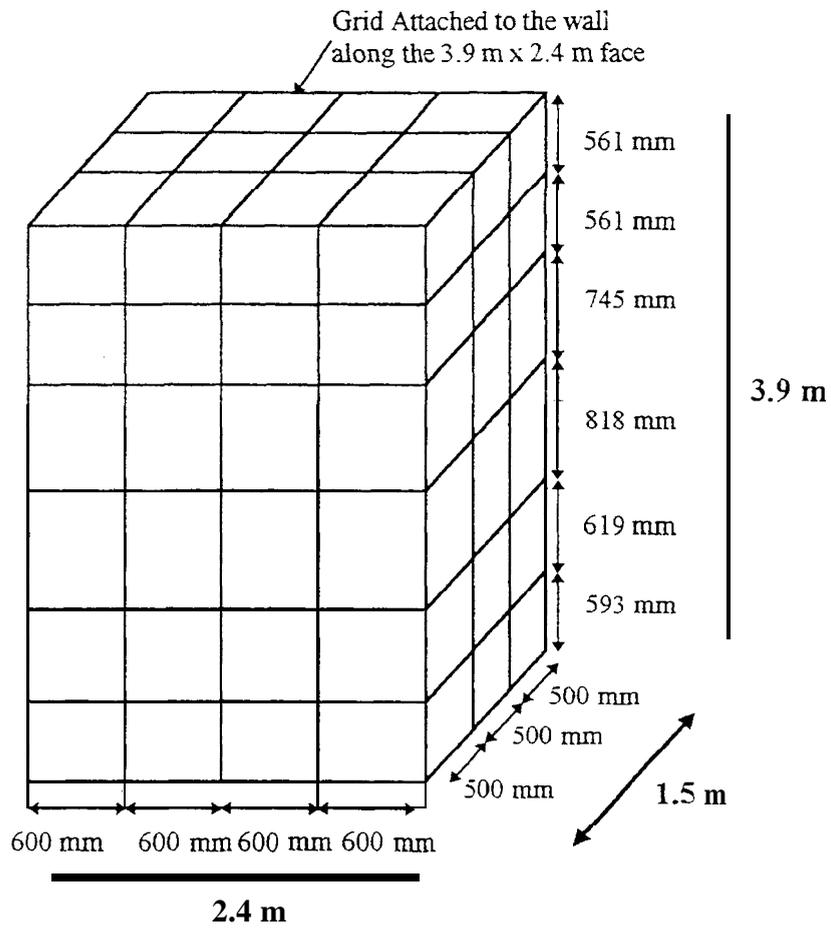
Figure 27: Thermocouple grid on the south wall of building (note: thermocouples attached to each grid point intersection, 140 thermocouples in total)

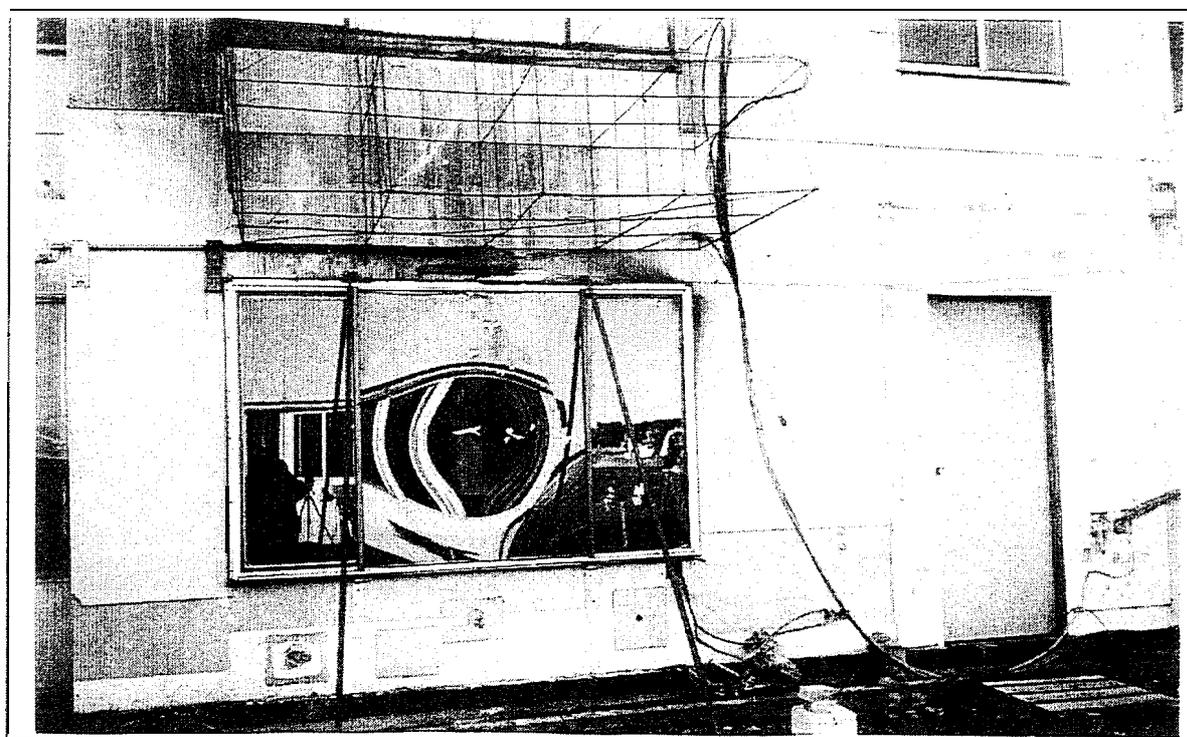
Figure 29: Initial bowing of the middle pane of the burn room window

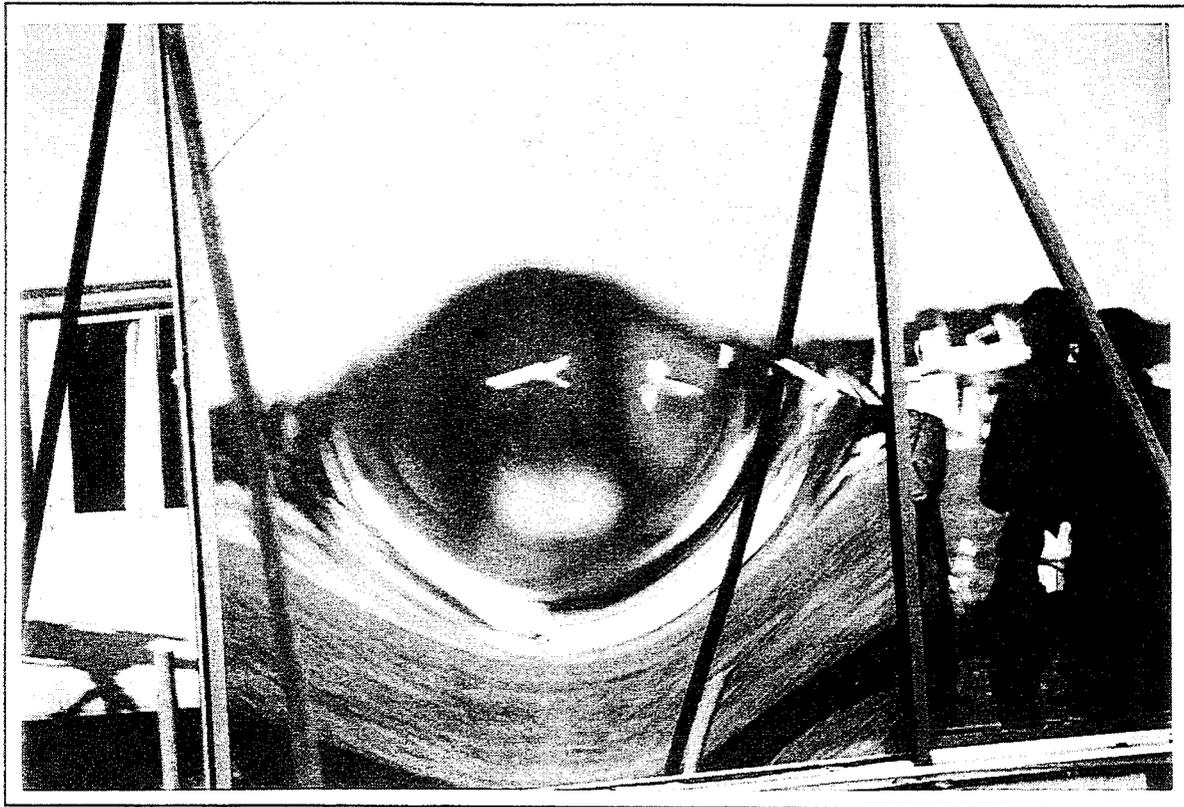
Figure 30: Severe bowing of the burn room window

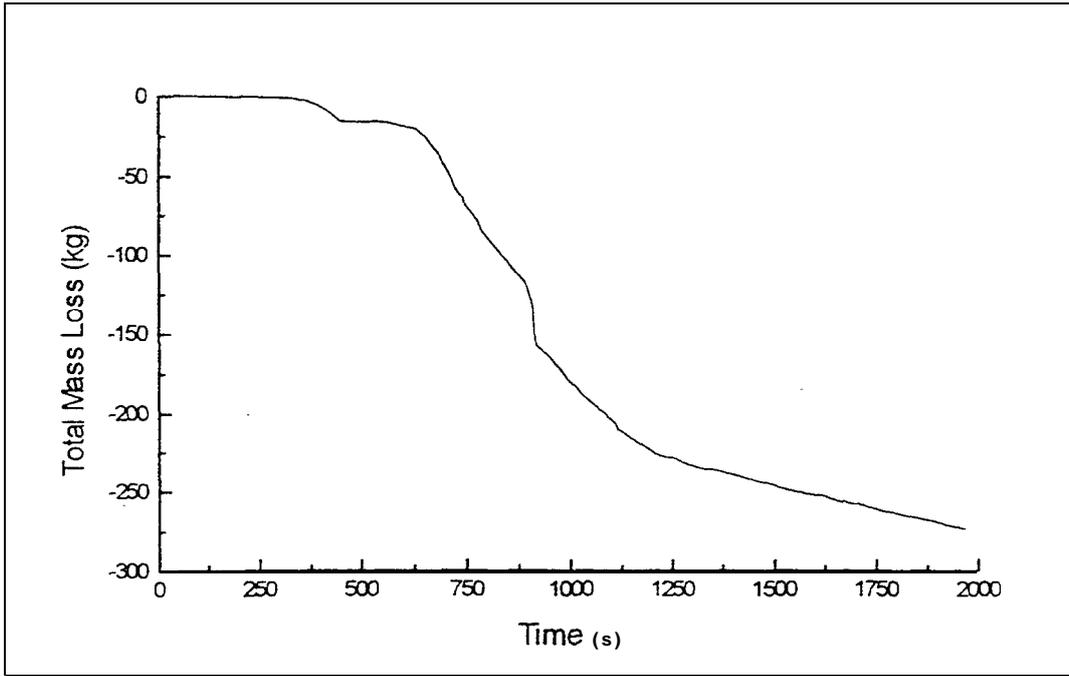
Figure FO 1- 1: Combined mass loss in the bum room

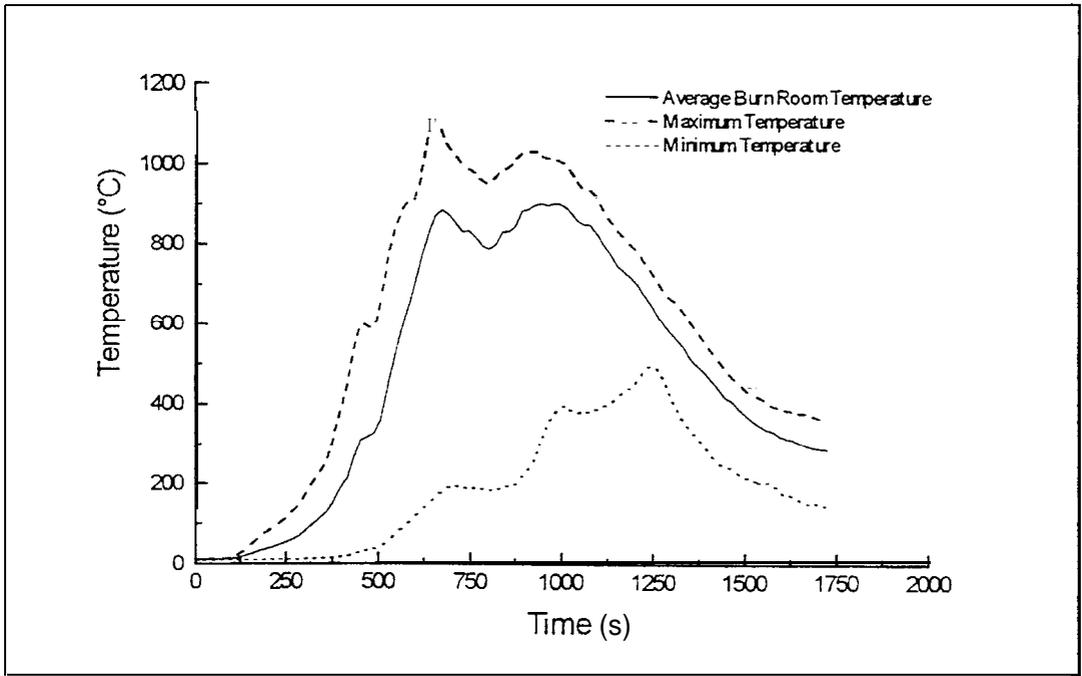
Figure FO4-3 : Average, maximum and minimum temperatures in the burn room

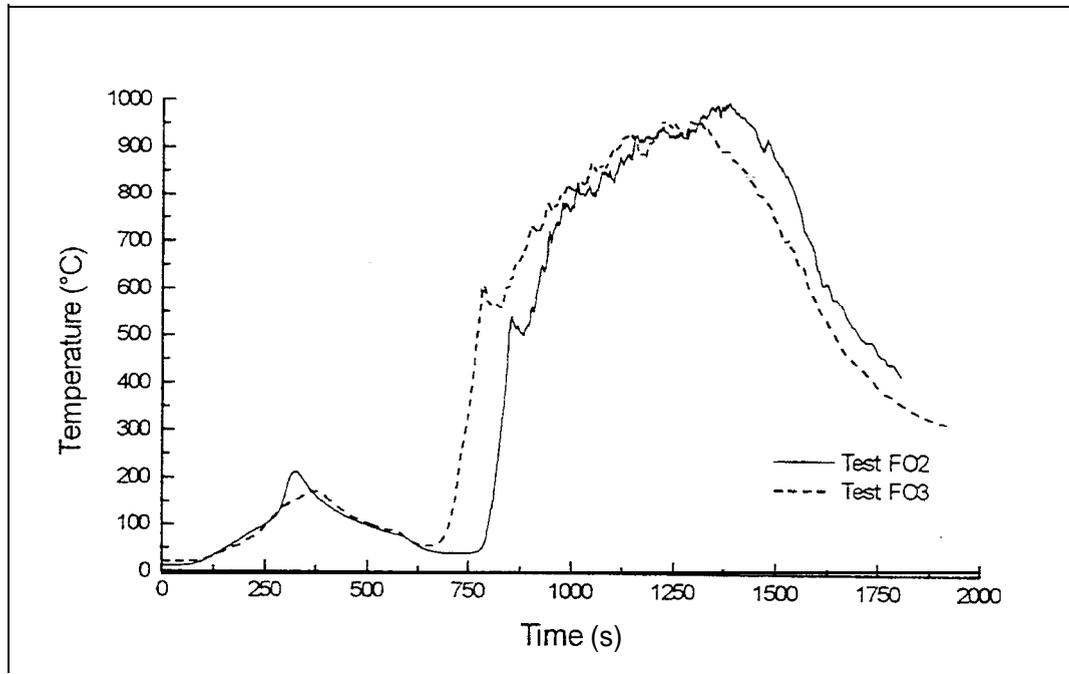
To check repeatability of the fire tests two were done under the same conditions; F02 and F03. The results were very similar as can be seen in Figures 38 and 39. The delay seen in F02 when compared to F03 was due to the window being lowered later in F02 than in F03.

Figure 38 : Average burn room temperature for F02 & F03

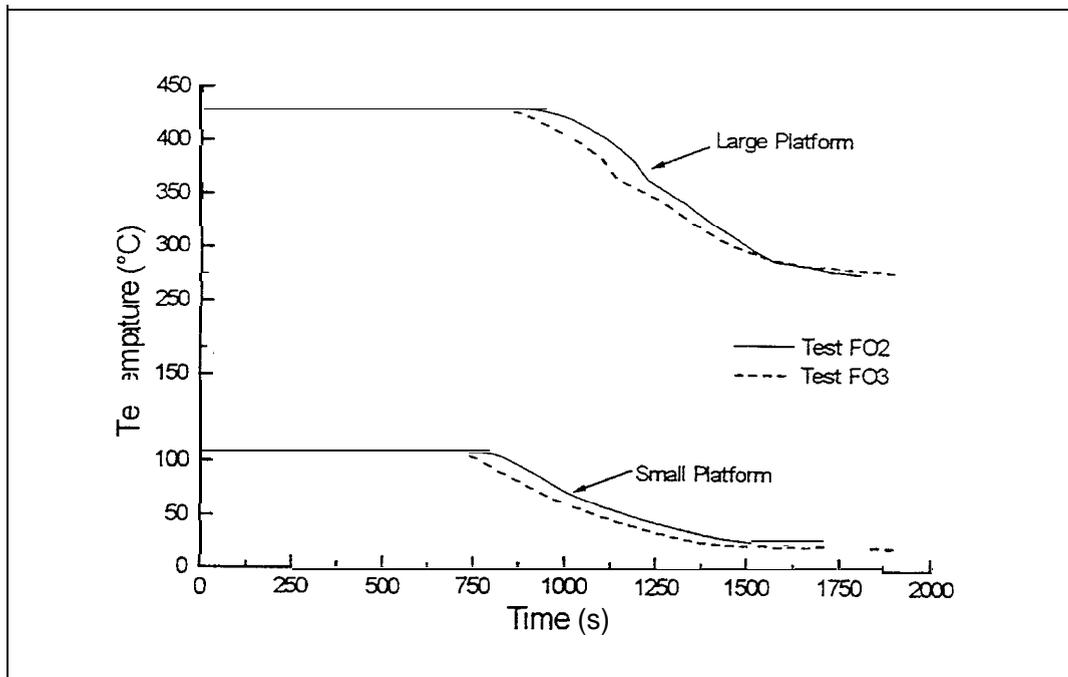
Figure 39 : Mass Loss on each platform in the burn room for F02 & F03

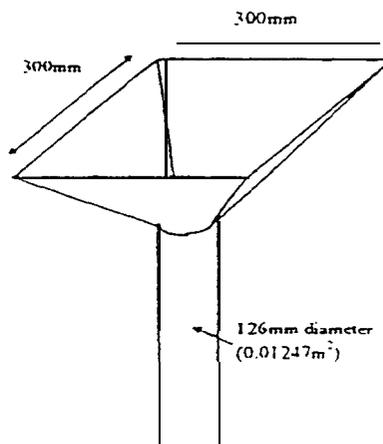
Once the operation had been set up correctly, base measurements were taken to observe the gross air supply quantities. A flowhood was constructed, and used in conjunction with a wind vein anemometer to measure air flow rates

Figure 1 Flowhood construction
