Technical Report
FCRC – TR 96-12

Large Scale Experiments
for Validation of Bldg Fire
Performance Parameters

FCRC Project 2 – Stage A
Fire Performance of Materials

*LARGE SCALE EXPERIMENTS TO
PROVIDE DATA FOR VALIDATION OF
BUILDING FIRE PERFORMANCE PARAMETERS*
by

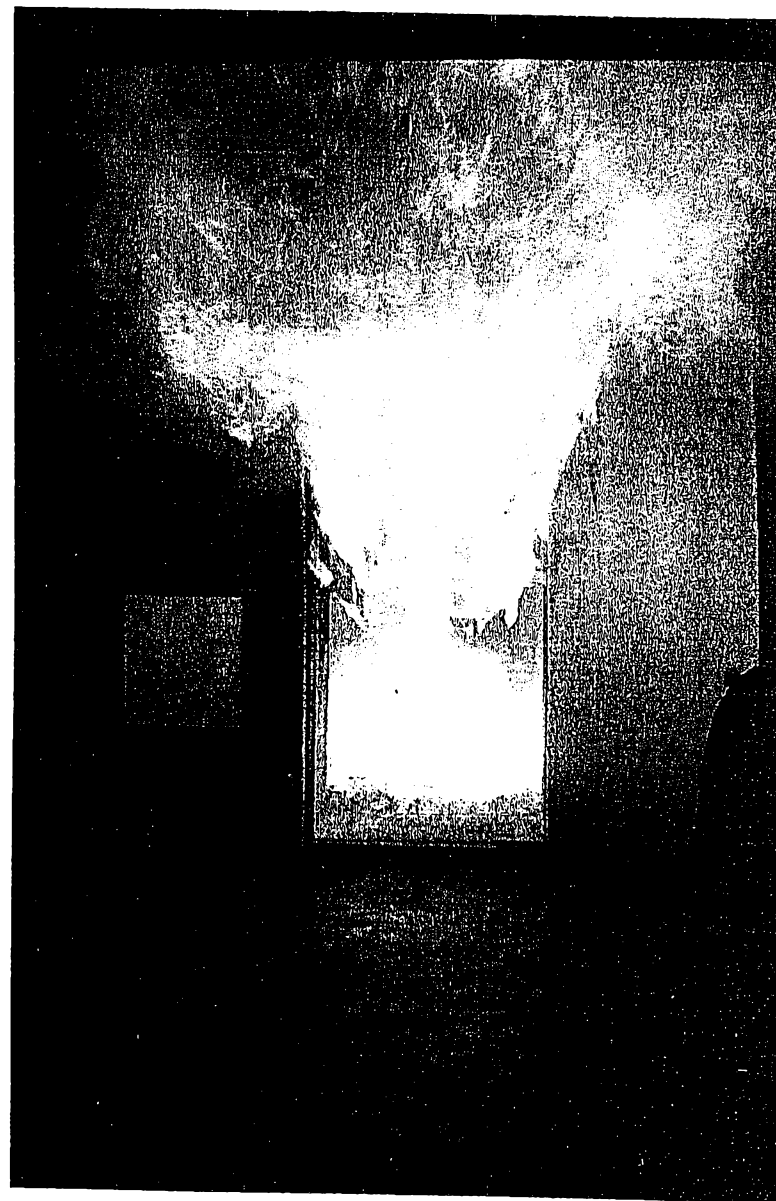
Figure 24.

R7, 190 seconds after ignition.

Once the armchair became involved the adjacent wall panels also caught on fire and flames spread rapidly around the top of the walls. Flashover conditions were reached within 160 seconds (see Table 10) and Figure 23 shows paper targets burning on the floor shortly after this time. Figure 13 shows a rapid increase in the rate of heat release up to 4000 kW at the time of extinguishment, after 195 seconds. Figure 24 shows flames pouring out of the doorway down to around 0.6 metres, shortly before extinguishment.

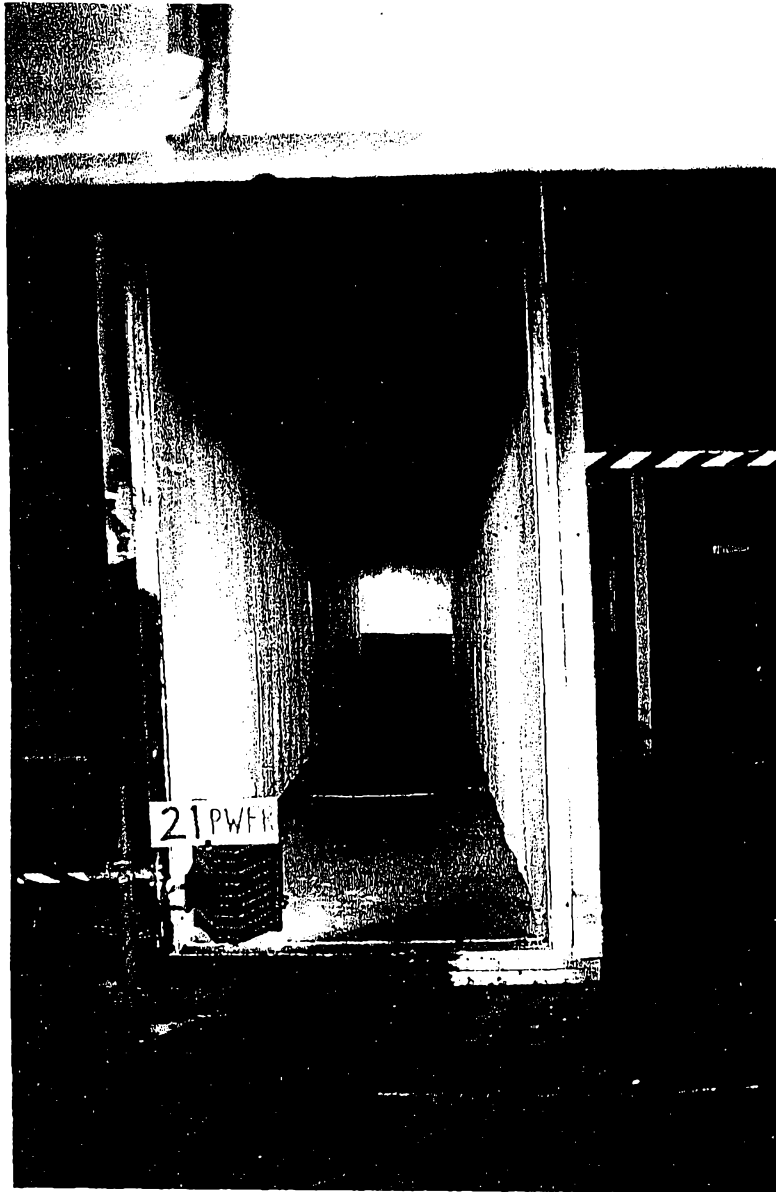
Figure 25. Sofa burn approaching flashover in the room attached to the fire test corridor.

corridor. The flames were extinguished after 30 minutes, by which time they had moved less than 5 metres along the top of the corridor wall. Figure 2.5 shows the sofa burning under a heavy cloud of smoke, just prior to flashover. Figure 26 shows small flames on one wall of the corridor, about 20 minutes into the experiment.

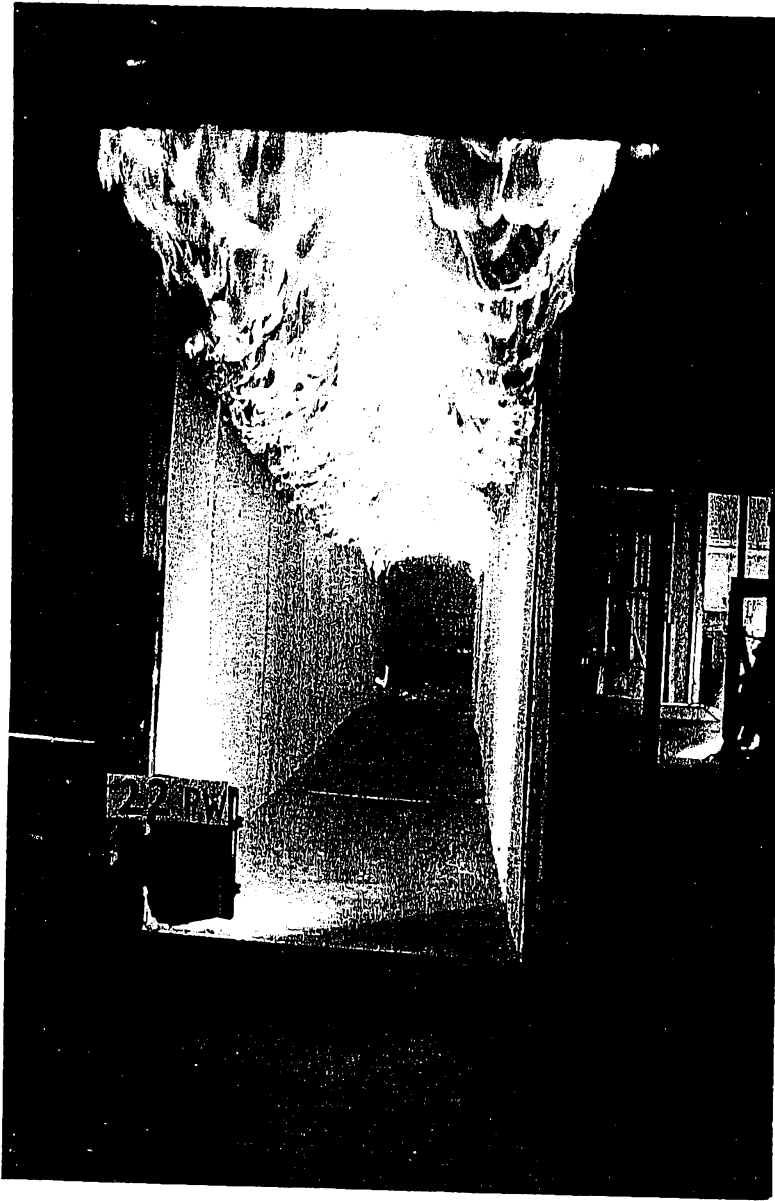
Figure 27. Plywood wall panels burning strongly (3500 kW) during Experiment C4.

Figure 18, the graph of rate of heat release versus time for this experiment, shows that the sofa bum was followed quickly by strong involvement of the wall panels. Flames began to issue out of the end of the corridor after 205 seconds, with the fire rapidly increasing in intensity to reach a rate of heat release of nearly 3500 kW at the time of extinguishment (270 seconds). Figure 27 shows the fire shortly before it was extinguished. Flames at the start of the corridor have reached about 1.2 metres down the wall panels. Flames at the end of the corridor are 0.8 to 0.9 metres deep.
